FLOATING DEBRIS IN THE STORAGE RESERVOIRS OF BAJINA BASTA AND POTPEC HIDROPOWER PLANT

Danica Zupanski

Institute for the development of water resources »Jaroslav Cerni«,
Belgrade, SERBIA
email:dzupanski@infosky.net

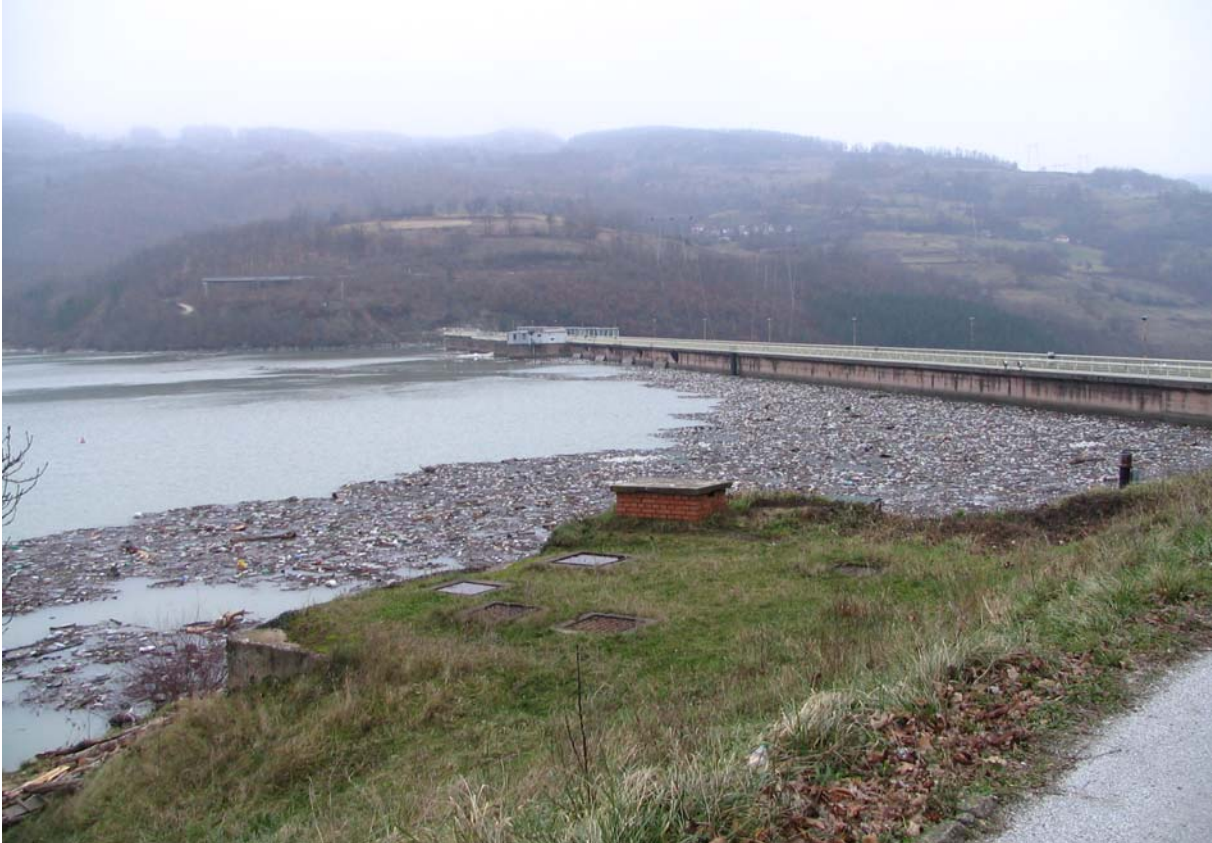
Fig.1 Hydropower plant Bajina Basta

Difficulties in the operation of HPP Bajina Basta are caused by the significant amount of floating debris which accumulates over girders decreasing the water inflow and thus hindering production of electric energy. An additional problem is forming of the shell colonies on the girders as well. It is believed that the increase in the shell number is related to the increase of the organic mater in the lake water and is probably of the same origin as the floating debris is. Based on the reports of the divers, who were manually cleaning the girders, there were some instances where more then 80% of the girders were covered. On this hydropower plant site, no problem with river bedload was observed
Up to this point, problem of the floating debris on the previous lake accumulations was solved by:

We determined that the floating debris mostly consists of: plastic bags, bottles and glasses, plastic packages, tires, dead branches and tree trunks, aluminum waste, carcasses, and other mud and organic waste materials on accumulations where it was found (Fig. 1 and Fig. 2).

For HPP Bajina Basta, lost energy power is 8 GWh which is around 14 million dinars annually, and lost power is around 15 MW, two months a year (estimated influence of debris) so that the total estimated loss HPP Bajina Basta is 24 million dinars annually.

- short-term (monitoring state of deposit, building in cleaners for removing deposits from girders, forming a special mobile unit for collecting the floating debris from the lake surface and procurement of boats and/or ships for collecting and transportation of the debris to landfill). These are the measures that should be in the annual maintenance plan of the hydro plants.
- Long-term (inter municipal cooperation in the river network, sanitize existing landfills, construction of sanitary landfills out of the flooding areas).

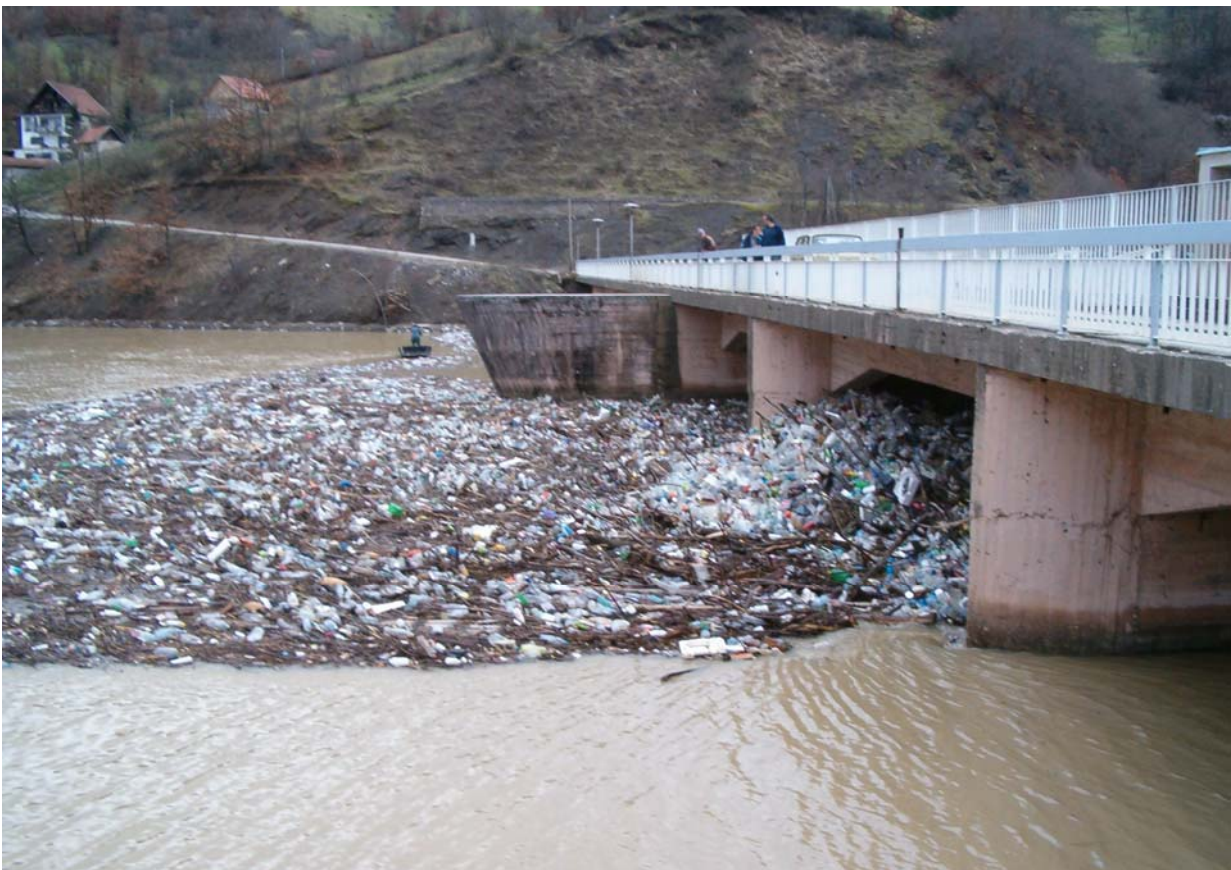
Fig.2 Hydropower plant Potpec

Difficulties in work of HPP Potpec are caused by the large amounts of river bedload which is being deposited at the bottom, as well as by the large amount of floating debris. Debris is floating or is deposited, blocking the lattice girders of the dams (Vukosavljevic S. 2000).

- Floating debris consists of dead branches, leaves, plastic bottles and bags. Debris covered an area of 15 by 20m, and is at the depth of 0.5-0.7m.
- Suspended debris consists of smaller branches, plastic bottles, plastic bags. Debris is entangled with the organic mud materials
- Settled debris is located at the bottom, and is of 4.5 to 5m height. It consists of tires, plastic packages, and entangled with plastic bags.

Estimation study of electric energy losses caused by the floating debris has been conducted. For HPP Potpeć we have used data for a 6 year period (from 2000-2005). It was estimated that for lost electrical energy of 7.45 GWh yearly, financial loss is 13 million dinars plus lost power of 7.09 MW (estimated with the 318,00din/kWh a month, and multiplied by 12 for an annual estimation) is 27 million a year, altogether adding up to 40 million dinars annually.
