Long-Term Alterations to the Varna-Beloslav Lake Complex due to Human Activities (Bulgarian Black Sea Coast)

Hristo Stanchev, Veselin Peychev, Atanas Palazov, Margarita Stancheva
Institute of Oceanology – Bulgarian Academy of Sciences
Varna, BULGARIA

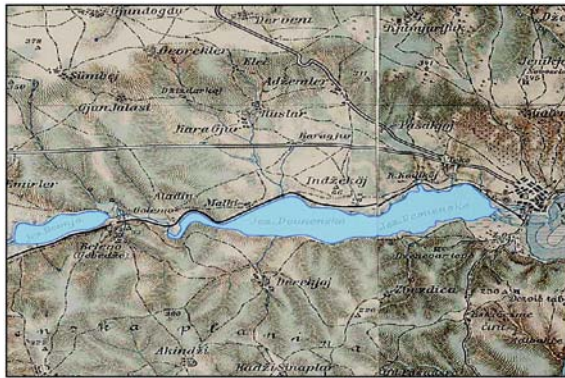
Figure 4. Study area before human impacts

On the historical maps from 1910 (Fig. 4) are pointed only the coastline configurations of the two lakes and the small river between them, and the old navigational canal, connected Varna Lake with the sea. Hence, these maps were used to identify the shapes/coastline configurations and areas of the both lakes in the beginning of the past century in order to describe the natural state of the study area before increased anthropogenic intervention. On the modern nautical maps from 1994 in scale 1:10 000

Digging of the new Canal-1 in 1976 was operated through the existing large sandy spit (its remaining part is Asparuhovo beach at present) and thus causing dramatic alterations of the beach area and length. As a consequence, the coastline length of the beach was shortened with 837 m and the beach area was reduced with 56446 m² compared with its parameters in 1961 (Fig. 1; Fig. 4), (Stancheva et al., 2007).

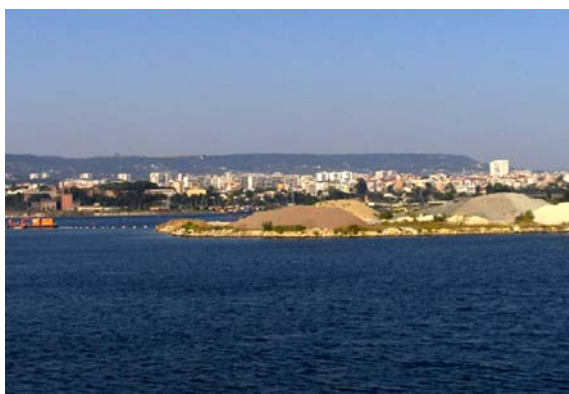
Figure 8. The "Island" where the dredged sediments are deposited (August 2009 - M. Stancheva)

In the beginning of the past century the coast along both lakes was entirely natural, with exception of the old navigational canal connecting Varna Lake with sea. On the contrary, at the end of the XX century navigational canals with total length of 8450 m have been dug and a number of large industrial ports, mentioned above have been built. According to the data of Executive Agency "Port Administration" – Varna, the total length of the ship berths to these ports at the area of both lakes have reached up to 5853 m, as the number of ships berths is 36 (<http://www.port.bg/bg/index.html>). The safe navigational depth is 12 m approximately, which requests implementation of constant dredging works in both canals: between two lakes and between Varna Lake and sea. Over the last few years the dredged sand has been deposited in the western part of the so-called "Island", which indeed is a remaining part of the former marsh zones at this area (Fig. 8; Fig. 9).

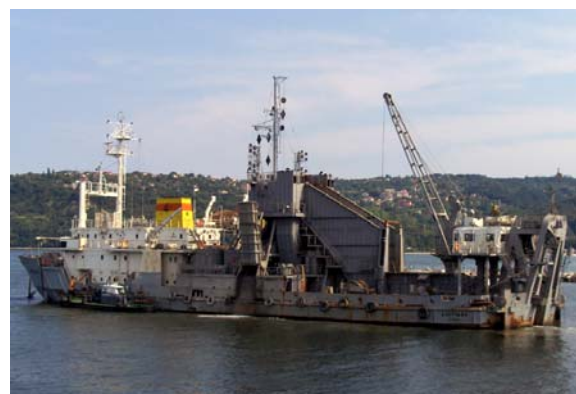
Figure 9. Dredging works in the Canal-1 (June 2009 – H. Stanchev)
